# Radiation Protection of FLASH2020+ at DESY

12<sup>th</sup> International Workshop on Radiation Safety at Synchrotron Radiation Sources

Ted Liang, Simon Bohlen, Albrecht Leuschner, Eva Panofski, Sven Zander

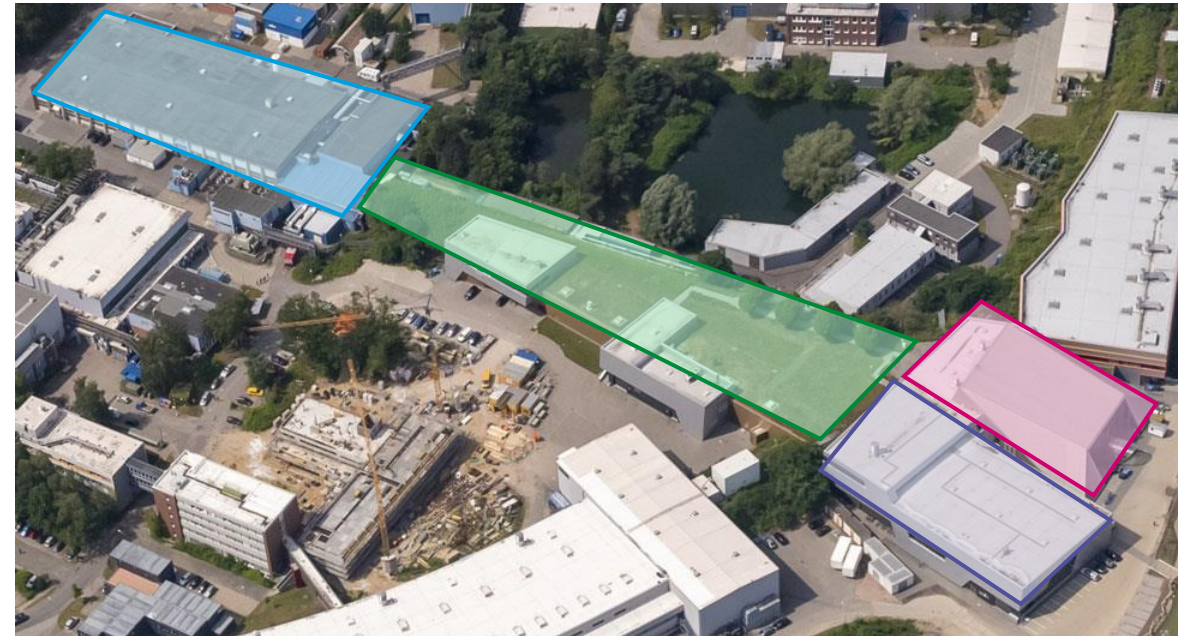
Aerial view of the FEL facility and supporting infrastructure

- Electrons are generated in the **hall at the top left** and traverse through a **tunnel (grass-covered section)**, reaching energies of up to 1.6 GeV
  - Electrons pass through undulators in tunnel
- At the bottom right are the **Albert-Einstein hall of FLASH1** and the **Kai-Siegbahn hall of FLASH2**, where users run their experiments
  - Footpaths on the grass-covered section mean the space above the tunnel is publicly accessible
- After the tunnel (and undulators), photon beam transport components of FLASH cross the PETRA ring
  - Access to the PETRA ring is possible by DESY personnel during FLASH operation (Controlled Area)

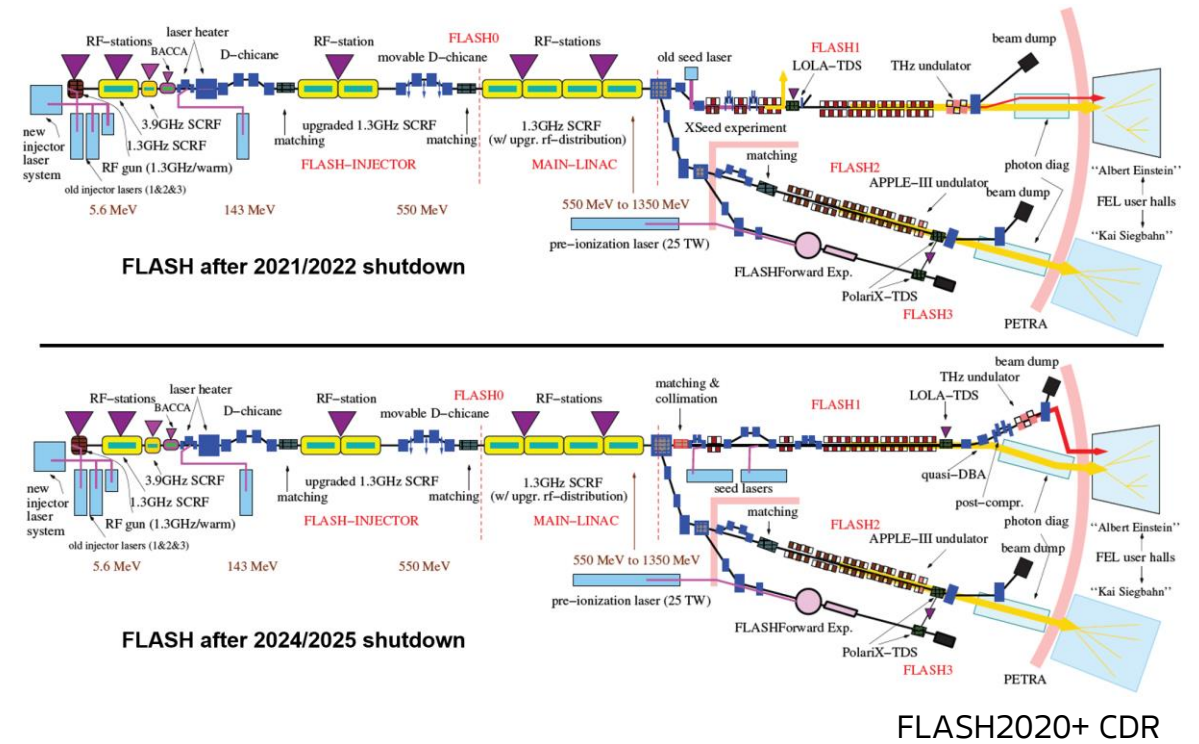
Change from fixed-gap to variable-gap undulators

Lateral shift in FLASH1 photon transport line

- Electron beam still terminates at beam dump
  - Maximum beam energy of 1.6 GeV remains the same
  - Maximum beam power of 102 kW remains the same
- In terms of radiation safety, the major change is a lateral shift in the FLASH1 photon transport line
  - Also a lateral shift in the beam dump
- FLUKA used to re-evaluate positions of local shielding for a range of accident scenarios
  - Locations of interest:
    - Albert Einstein experimental hall (downstream)
    - Conference room space (above)

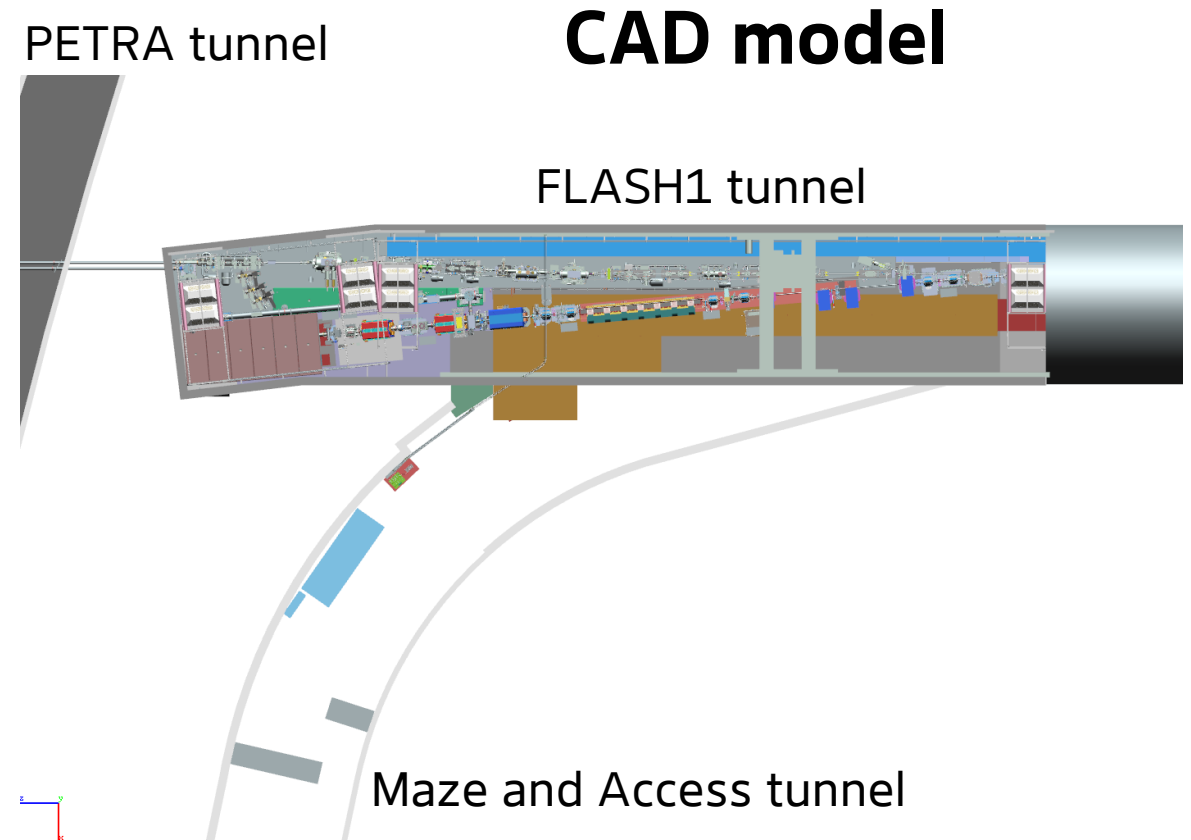
## Obtaining the CAD model of the FLASH facility

- Close cooperation with FLASH2020+ mechanical engineers allows building of FLUKA model per project's coordinate system
- Advantage of knowing coordinates of all components
- Version control of CAD model via TeamCenter

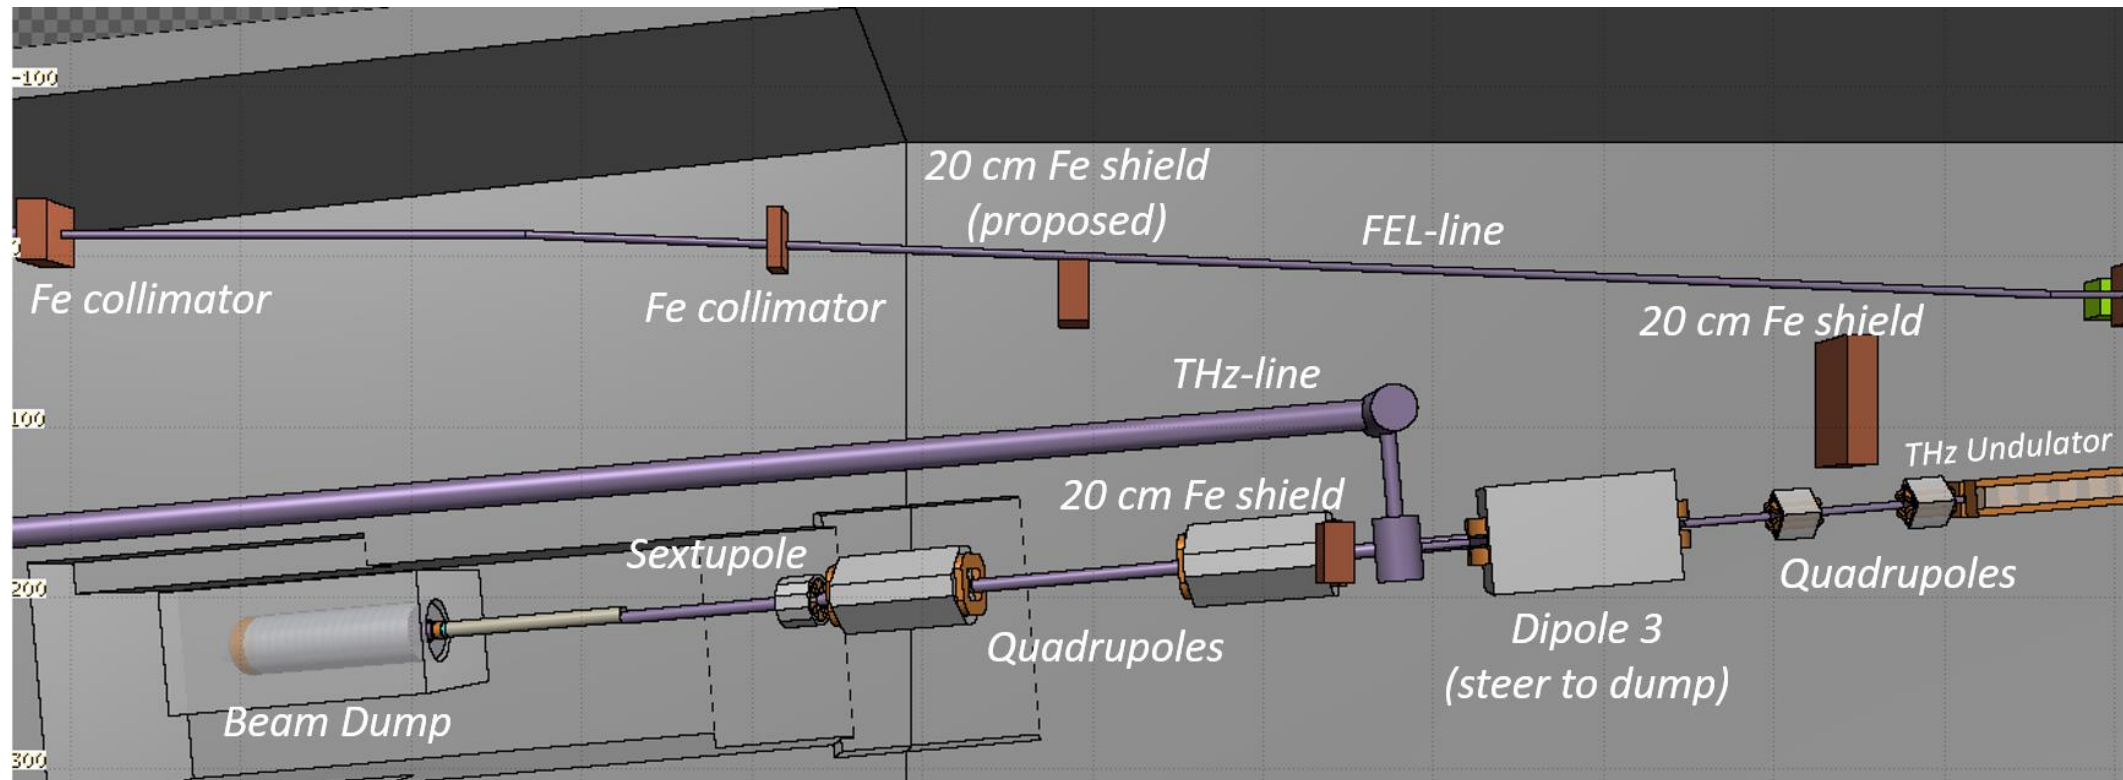
FLUKA model includes major components (magnets, pipes, shielding, beam dump, etc.)

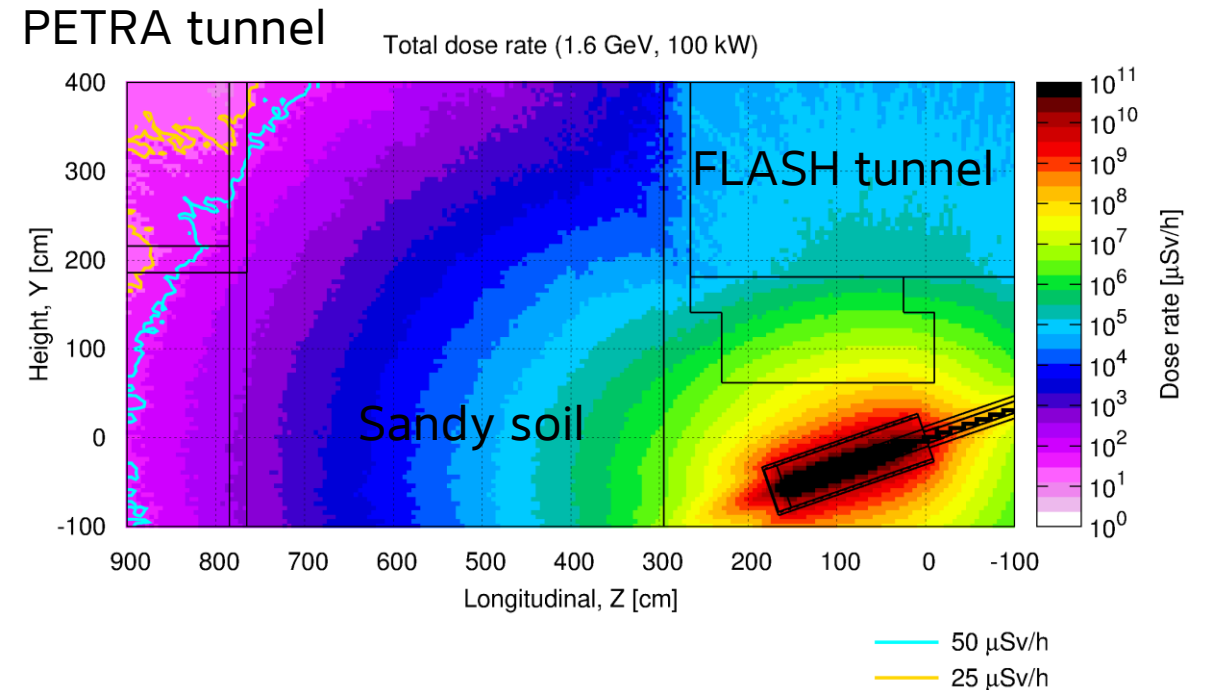
## Dose rate at PETRA tunnel downstream

- Electron beam steered towards its intended beam dump
- PETRA tunnel downstream from FLASH tunnel:
  - ~6 m horizontal distance between two tunnels
  - ~4 m vertical distance between bottom of FLASH1 beam dump and PETRA tunnel
- Possible to access this section of the PETRA tunnel during shutdown/maintenance at the same time when FLASH is in operation
  - PETRA tunnel is a Controlled Area
  - Unlikely occurrence, low occupancy

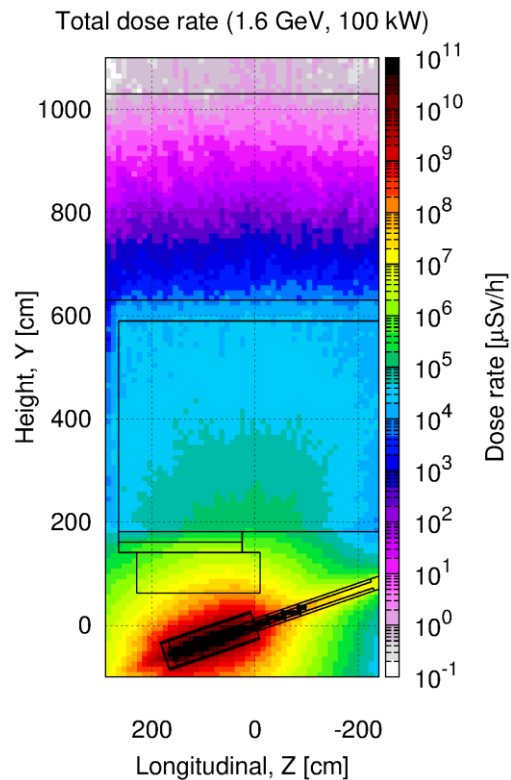
### Total dose

Dose rate at footpath above FLASH tunnel

- Applying neutron & photon filters to total dose...
- Neutron dose dominant above 4 m soil:  $1 \mu\text{Sv/h}$
- Area dosimeter stationed to monitor

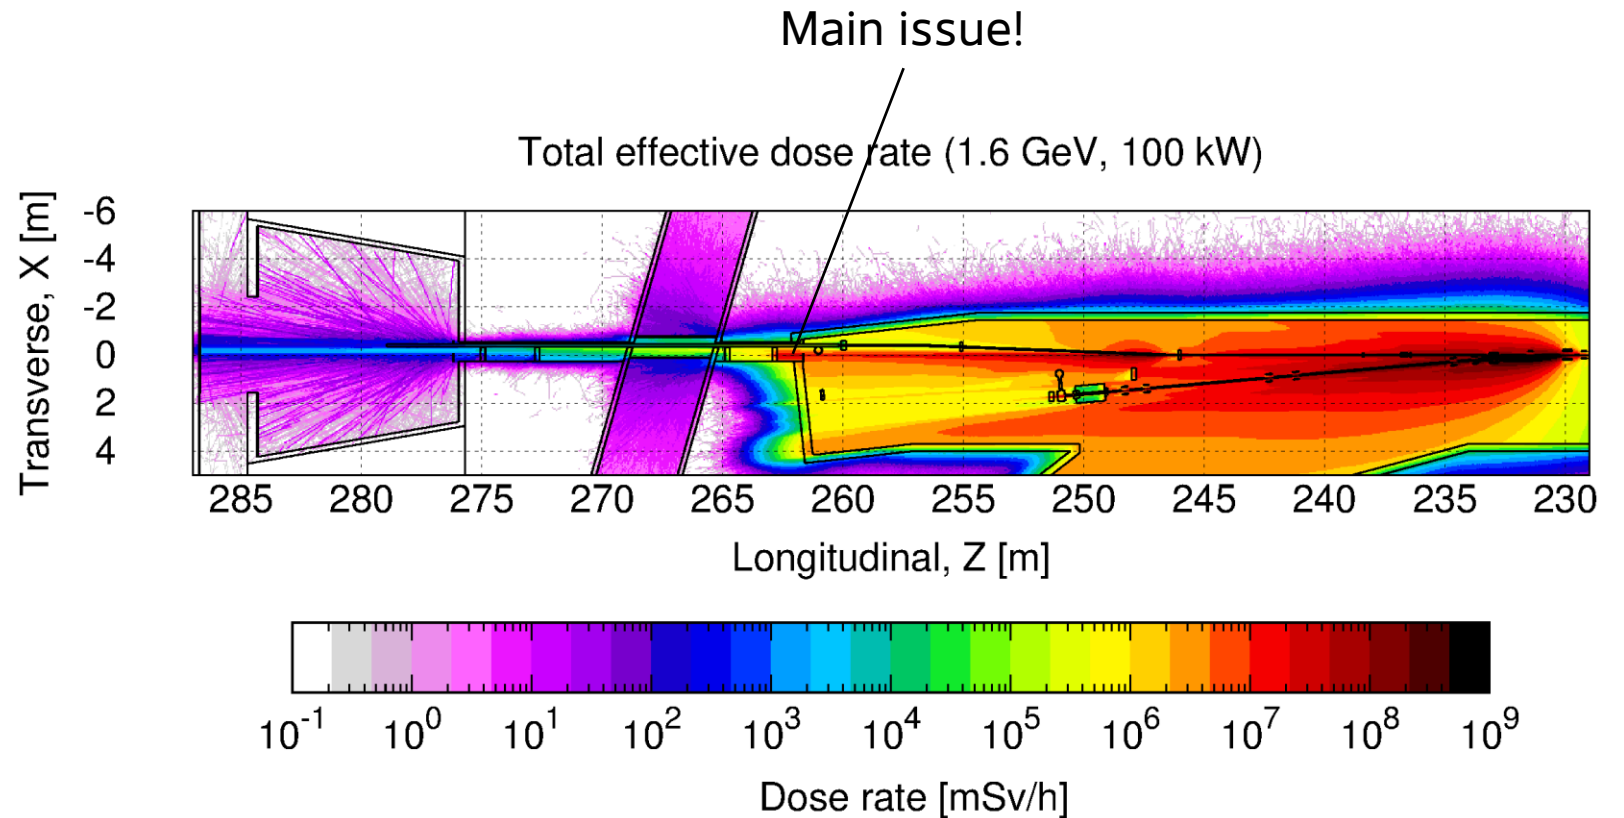
Malfunctioning vacuum valve upstream first bending dipole (worst case)

- Electron scattered on thin target before the before bending dipole
- Scattered electrons and forward  $0^\circ$  bremsstrahlung from thin target beam loss stream down FEL-line and into duct between FLASH1 and PETRA tunnels
- **Hundreds of mSv/h and even few Sv/h** dose rates in PETRA tunnel and Experiment Hall (!!)
- **Solution: Additional 20 cm Fe shield** to attenuate this ray and bring dose to few mSv/h

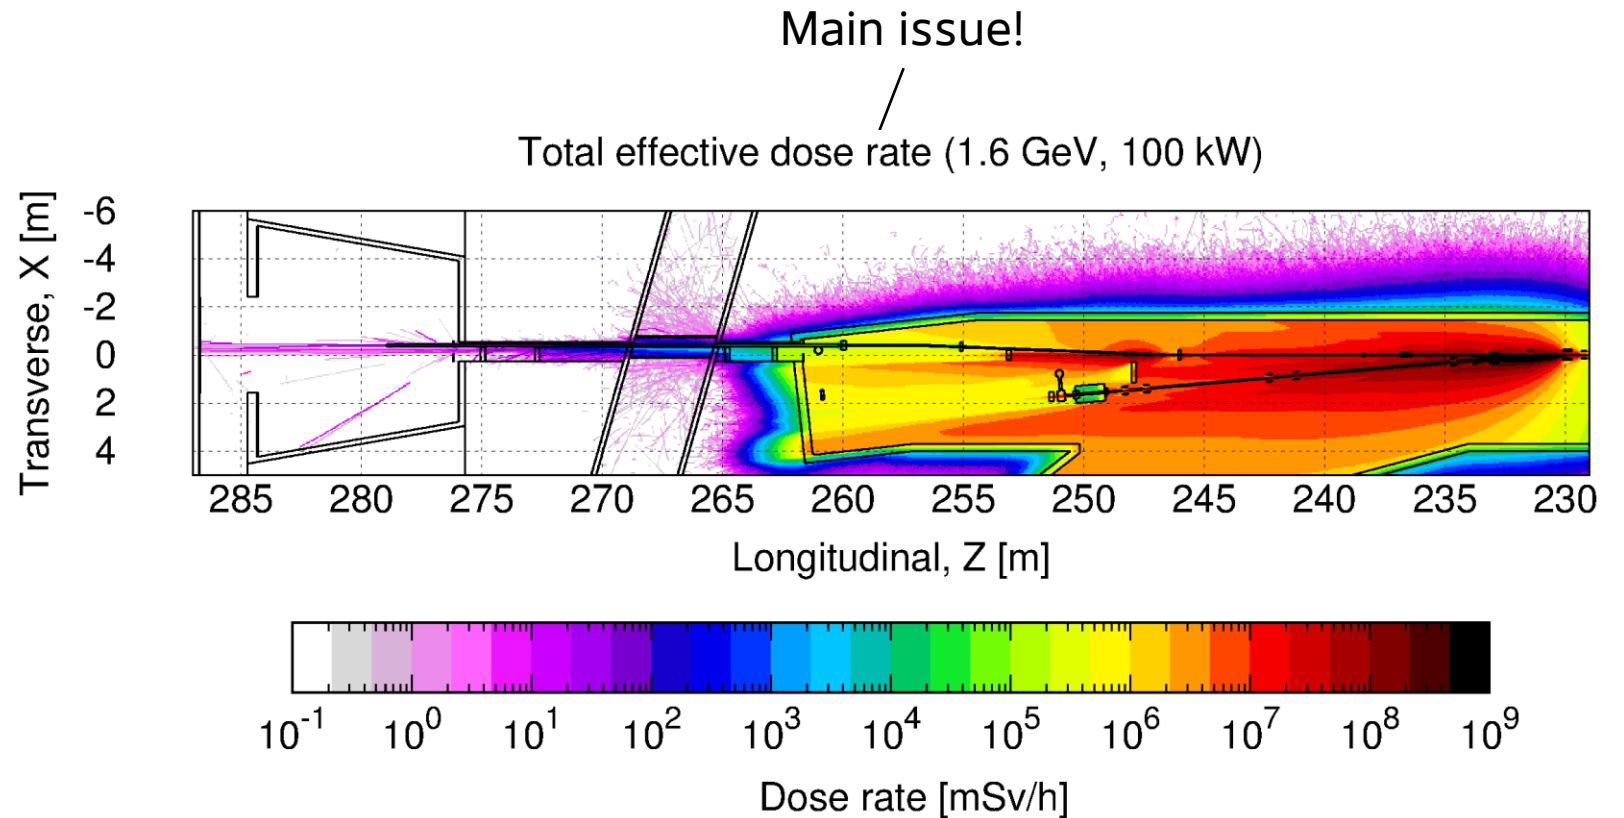
Malfunctioning vacuum valve upstream first bending dipole (worst case)

- Electron scattered on thin target before the before bending dipole
- Scattered electrons and forward  $0^\circ$  bremsstrahlung from thin target beam loss stream down FEL-line and into duct between FLASH1 and PETRA tunnels
- **Hundreds of mSv/h and even few Sv/h** dose rates in PETRA tunnel and Experiment Hall (!!)
- **Solution: Additional 20 cm Fe shield** to attenuate this ray and bring dose to few mSv/h

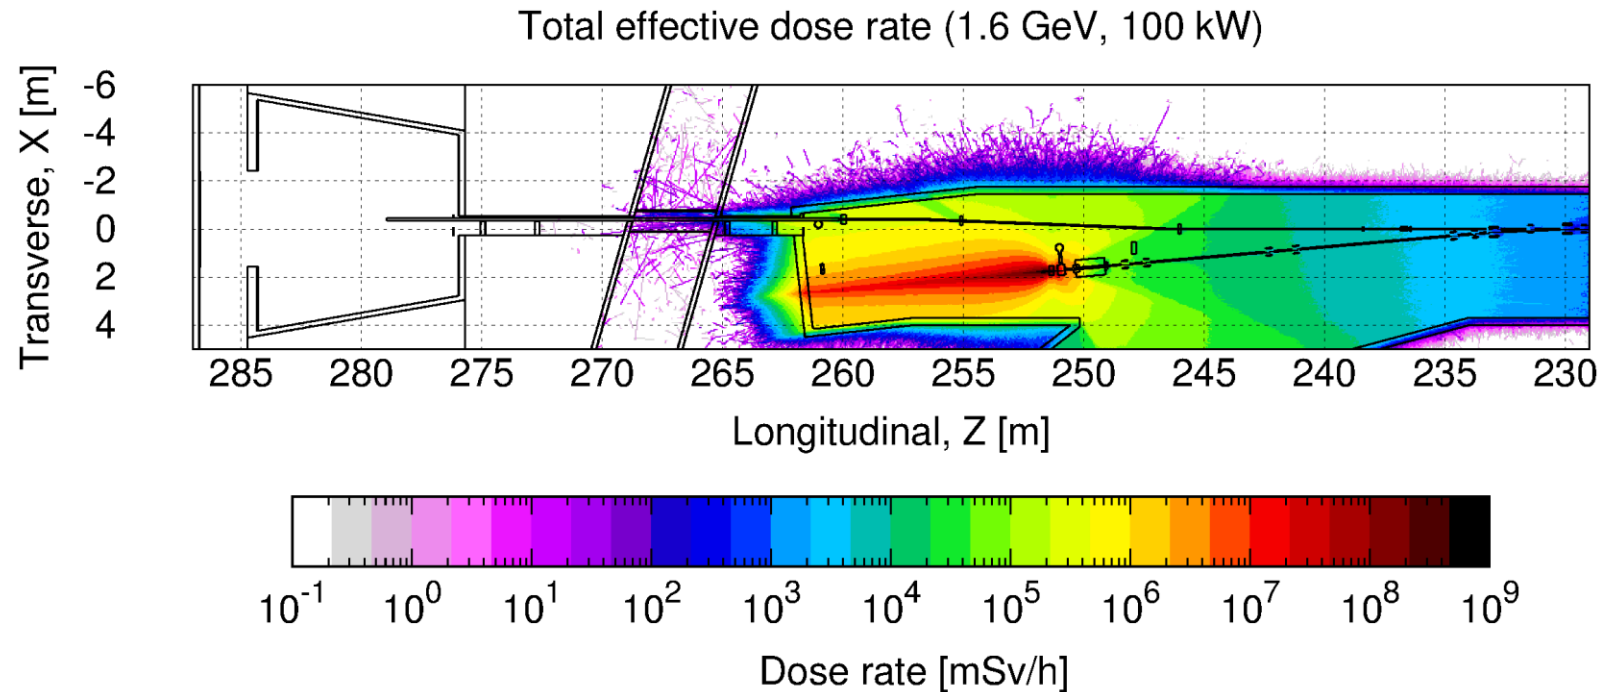
Bending dipole 3 has no field strength and fails to steer beam to dump

- Solution: Electrons hit the 20 cm Fe shield located at  $Z = 251$  m
- Bremsstrahlung shower very forward-pointing into end of FLASH1 tunnel
- The Fe shield + earth are enough to reduce dose to PETRA tunnel

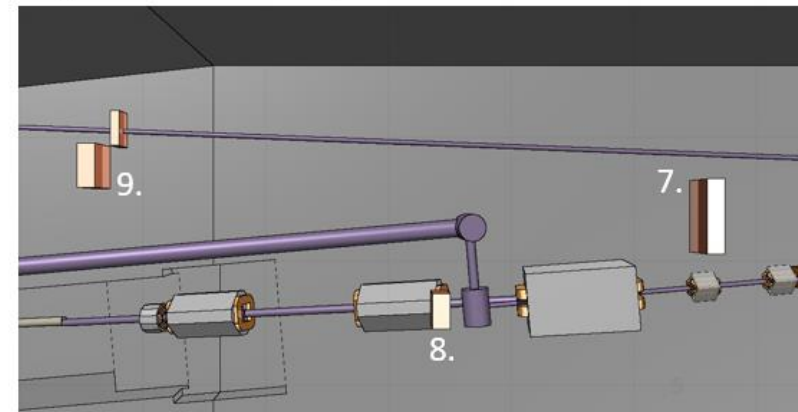
Dimensions and specifications based on CAD model's coordinates

7. Fe shield: center @ X,Y,Z = (0.654 m, 0 m, 248.235 m)
  - 85 cm wide x 50 cm tall x 20 cm thick
8. Fe shield: center @ X,Y,Z = (1.733 m, 0 m, 251.345 m)
  - 40 cm wide x 50 cm tall x 20 cm thick
9. Fe shield: center @ X,Y,Z = (0.075 m, 0 m, 255.380 m)
  - 50 cm wide x 50 cm tall x 20 cm thick

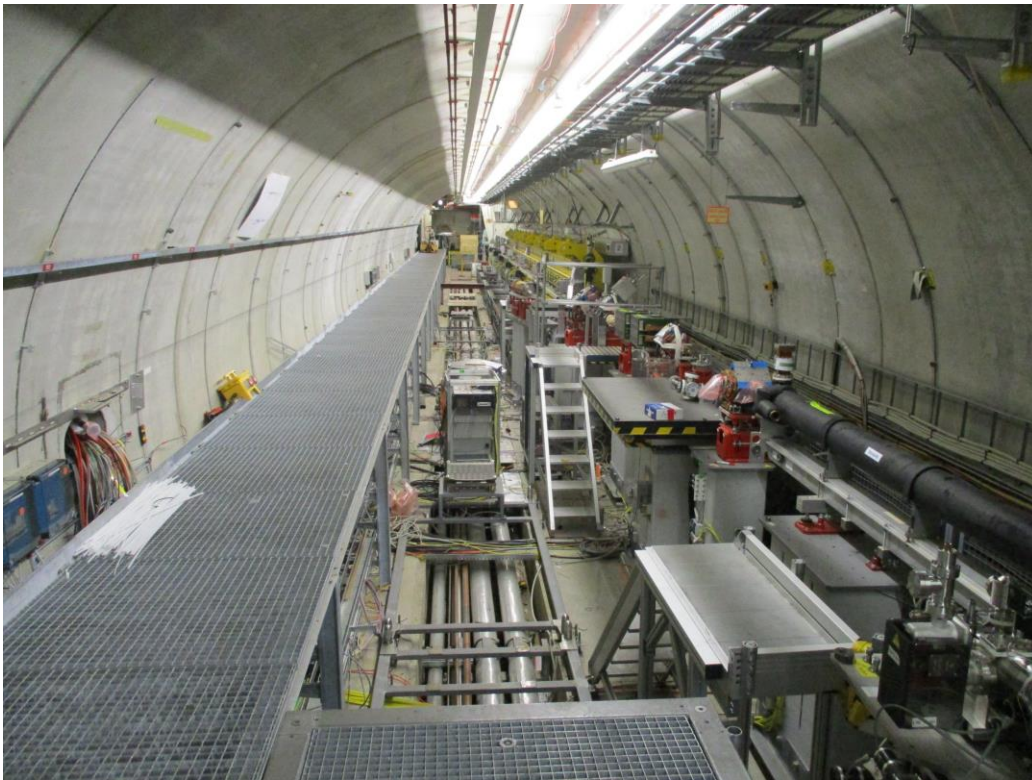
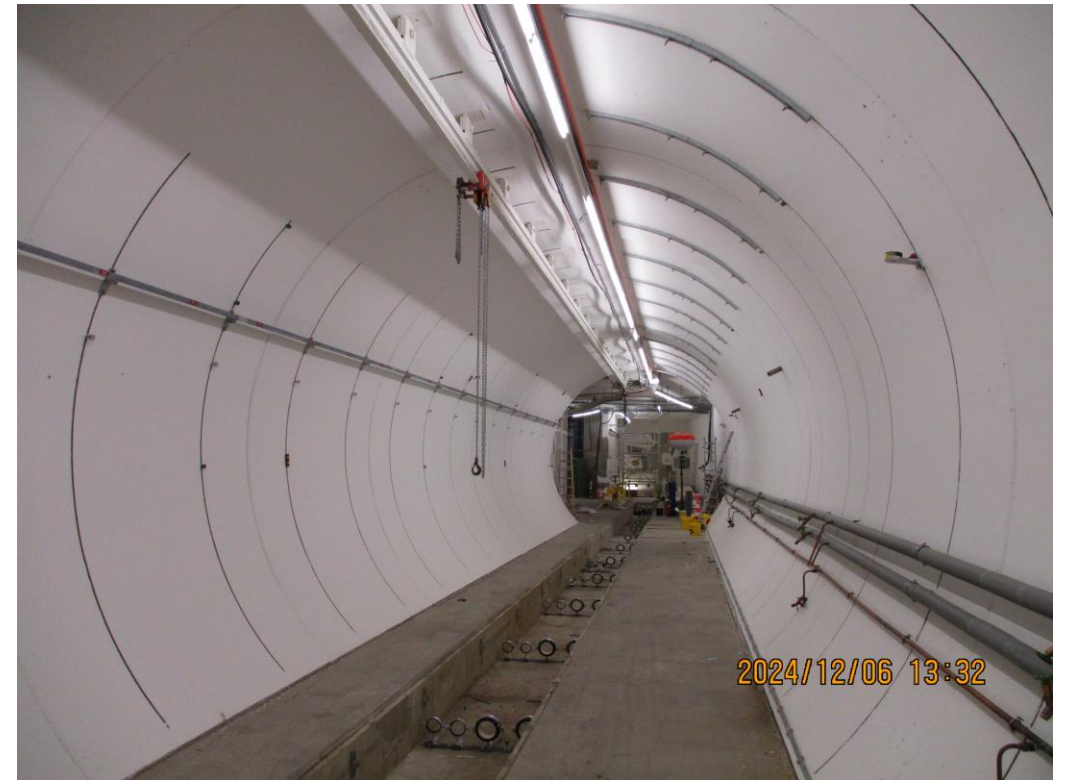
Large majority of components removed (and a new paint job)

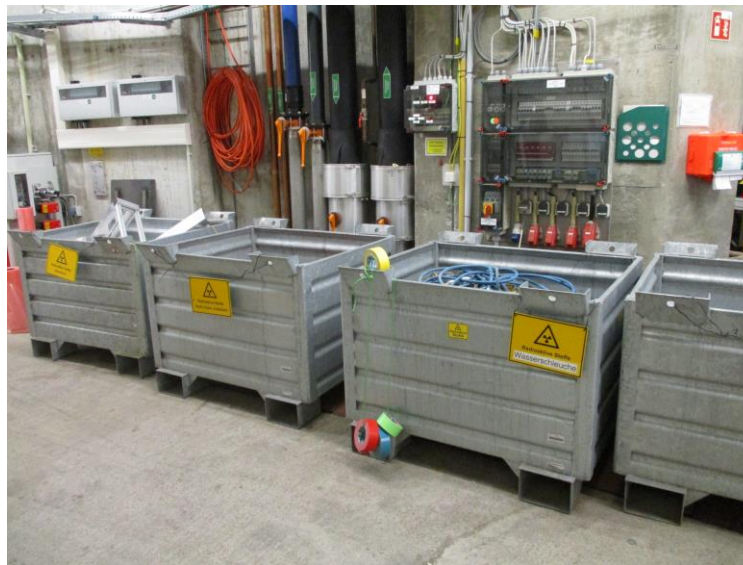
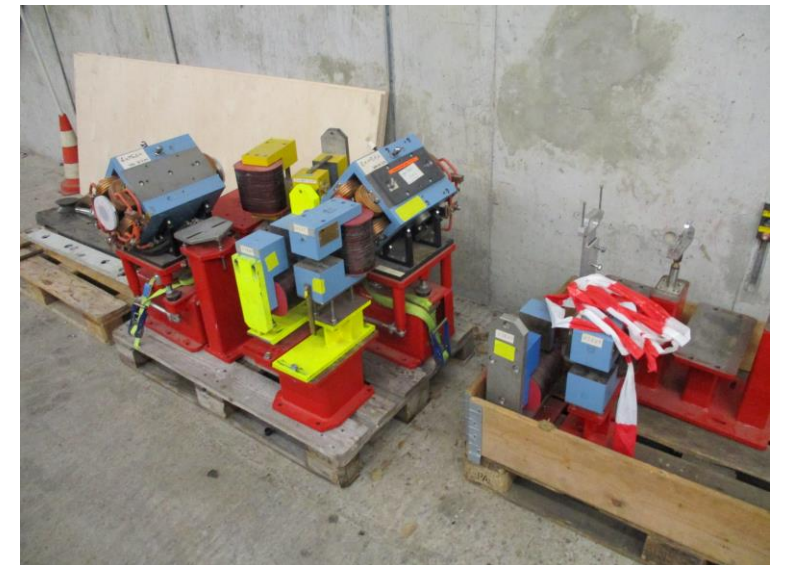
Tremendous amount of potentially activated material to be surveyed

- Demanding effort:
  - Responding to ticket system
  - Volume and amount of material
  - Cables cut into 1 meter lengths and surveyed on flat surface
- In the end:
  - About 100 tons of material removed from FLASH1 tunnel
  - About 80 tons required survey for release by 3 colleagues DESY radiation protection team
  - Less than 5 tons stored in radioactive material storage hall

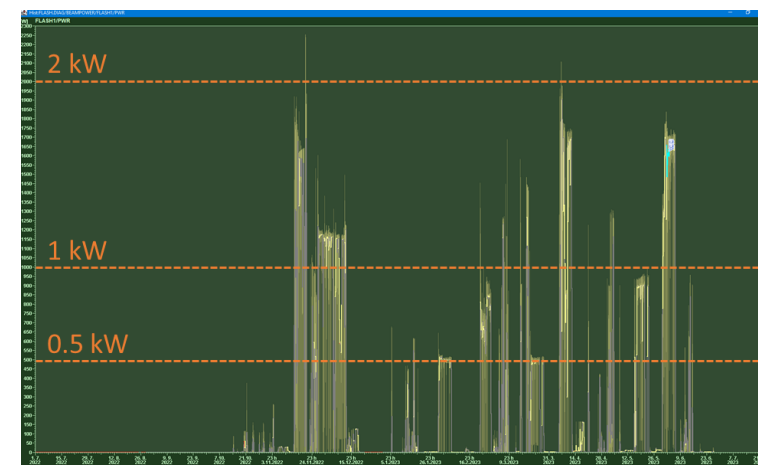
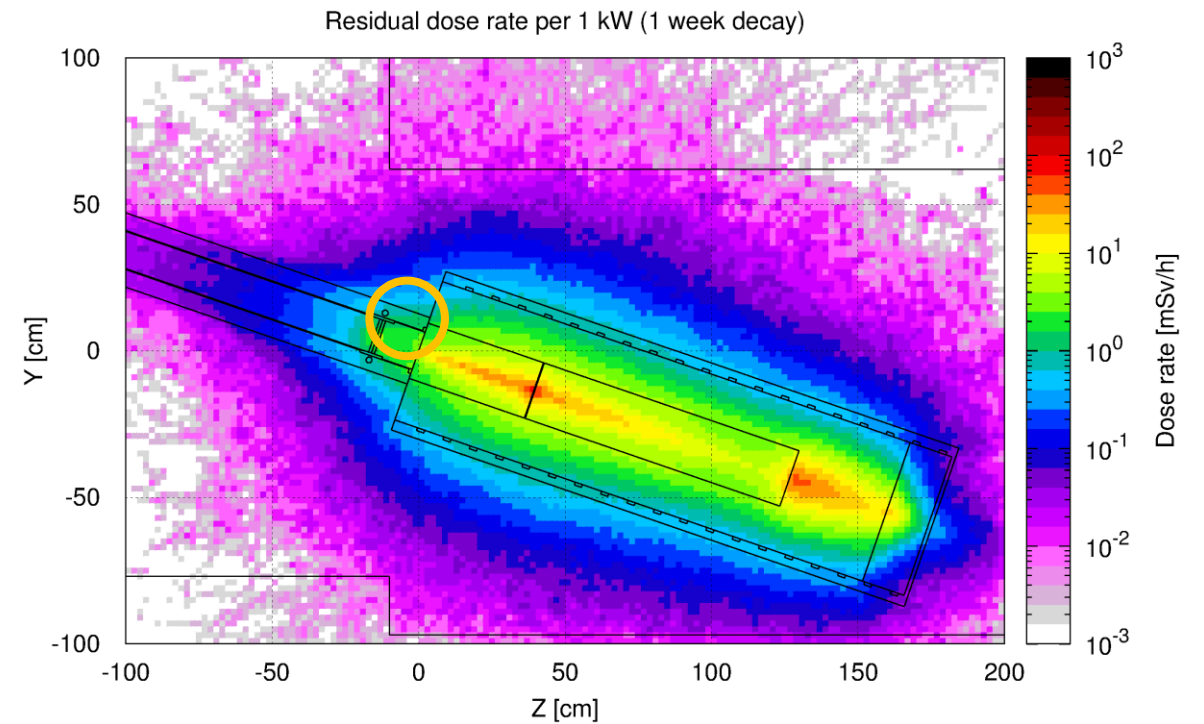
## Residual dose rate a concern

- Based on operational history of FLASH1:
  - Up to 2 kW periodically, but not the entire year
  - Average power of ~0.2 to 0.3 kW over 14.5 years
- FLUKA calculations provided estimate on residual dose rate at beam pipe at entrance to dump
  - Decision for cooldown time of 2 weeks
  - Closest contact point of entombed dump
    - Conservative estimate (1 kW): ~1  $\mu\text{Sv/h}$
    - Measured: 0.5  $\mu\text{Sv/h}$
- Beam dump interim storage at radioactive material storage hall and then moved back to FLASH1 tunnel

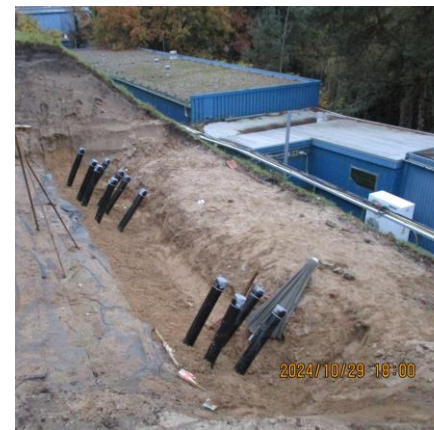
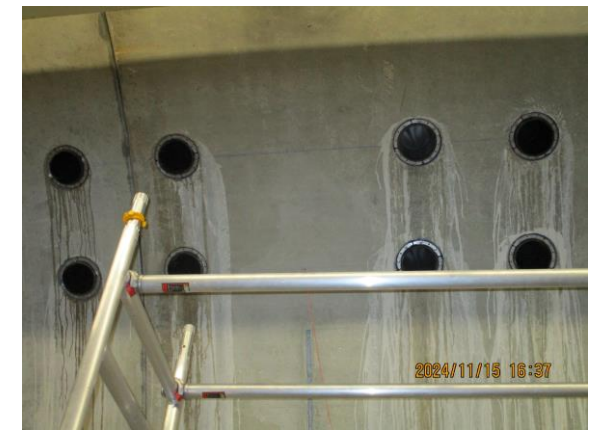
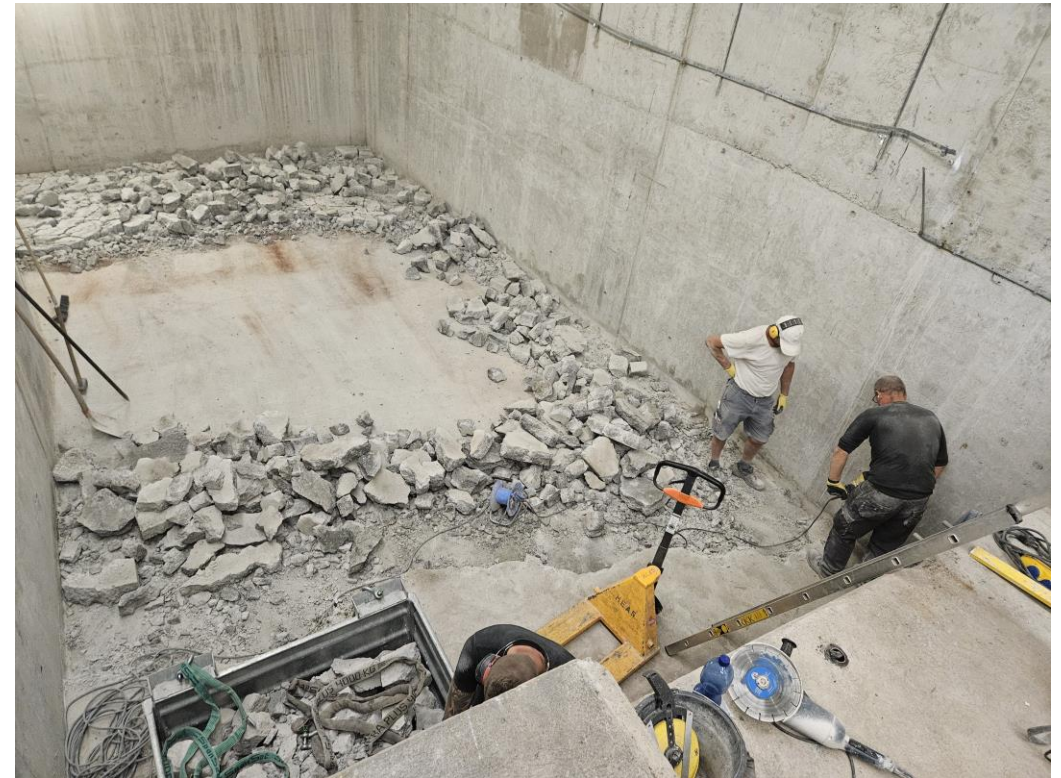
What did not go quite as well as expected

- Additional holes in FLASH1 tunnel shielding needed for infrastructure...but started leaking water from surrounding soil into the tunnel
  - → Engineering solution to prevent water leakage
- Unauthorized demolition of concrete inside beam dump pit (due to discovery of 10 cm additional concrete)
  - → Contractors unaware of potential activation
  - → Immediate stop and running concrete debris samples in gamma-spec
  - → Activation found in concrete BUT all radionuclides below release limits...near miss!
  - → Work permit required for any concrete work

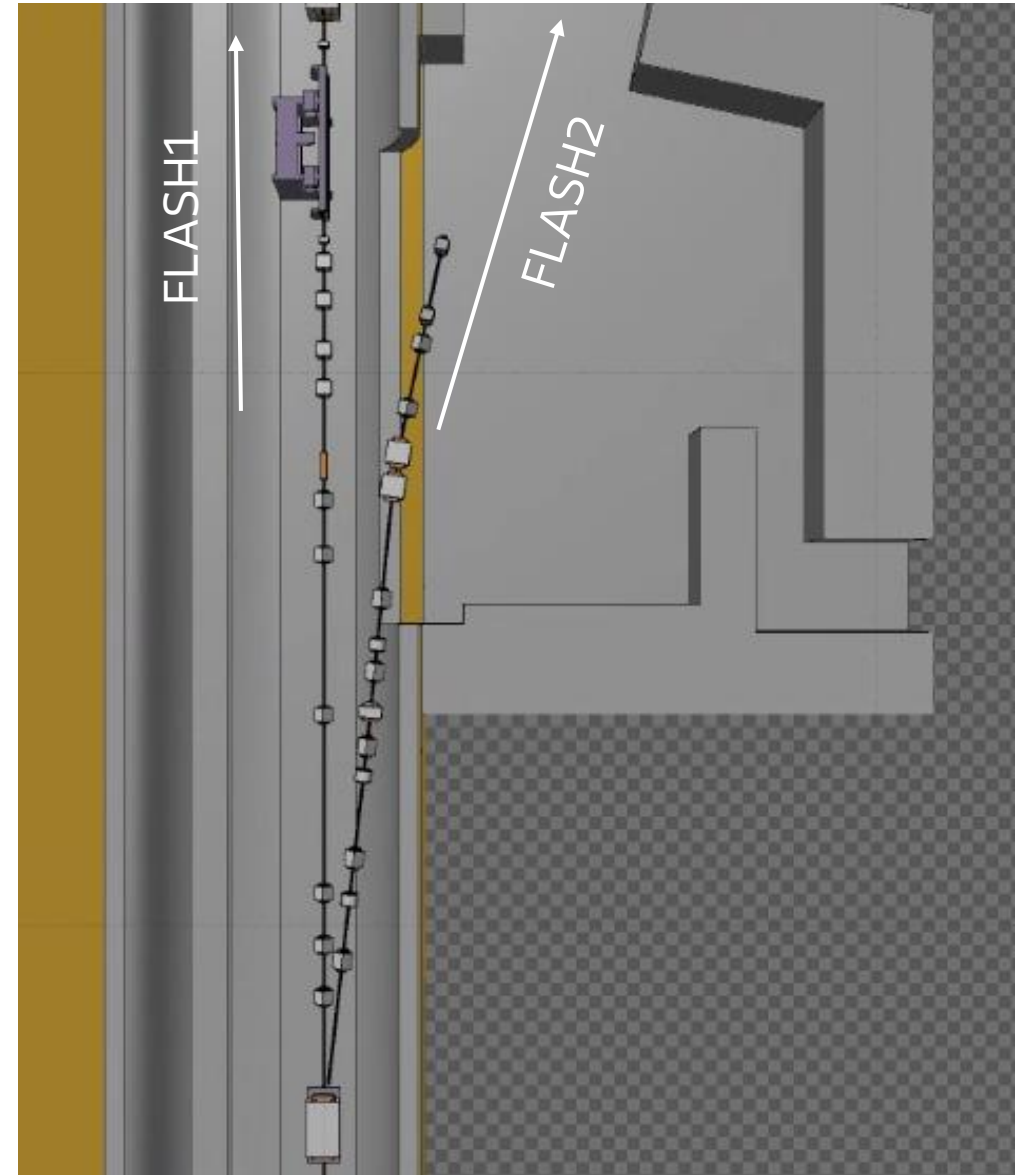
## Optimizing area dosimetry and local shielding

- Expanding model of FLASH1 tunnel upstream to include remainder of FLASH facility
- Using the new model to perform additional studies:
  - Characterize activation and dose environment at known beam loss locations at bunch compressors
  - Optimize local shielding for such losses
    - Protection of equipment and electronics
  - Optimize area dosimetry positions
    - Protection of personnel outside tunnel
